BUILDING SURVEY

42 XXXXX STREET, NORTHAMPTON, NNX XXX

SURVEY REPORT

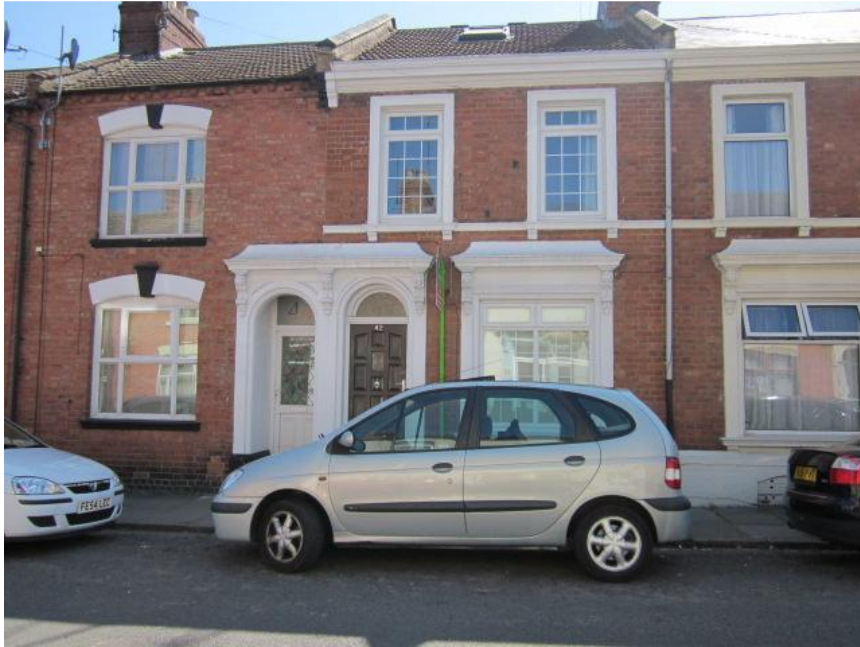
General view of the property
